Passenger Ship Evacuation Analysis with Fire Risk Assessment Approach Using NFPA 551

M Muradi¹ and W Mutmainnah¹

¹Research and Development Division, Biro Klasifikasi Indonesia, Jakarta, Indonesia

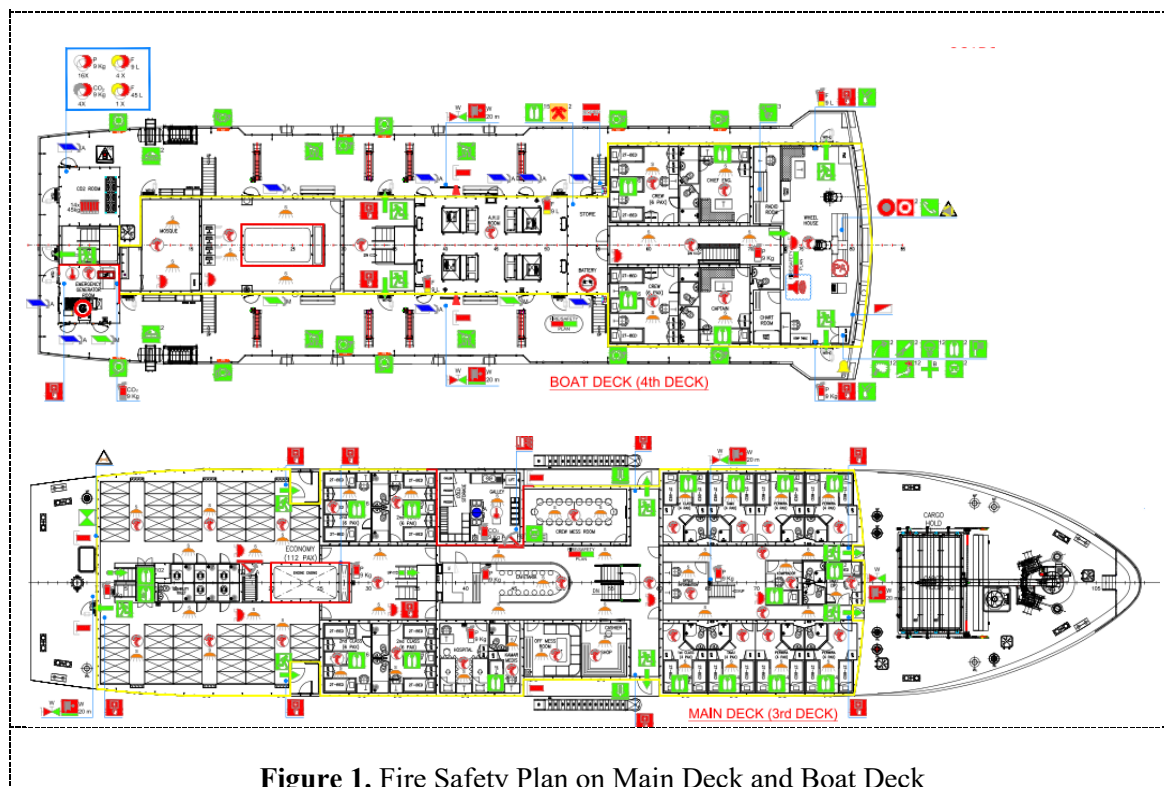
The evacuation route for passengers is very important when designing a ship, therefore it is necessary to evaluate the evacuation routes on the ship. The review of the evacuation route is based on the safety plan (Figure 1.) by identifying the evacuation routes for each deck to the assembly point.

Figure 1. Fire Safety Plan on Main Deck and Boat Deck
